## **Waste Management**

### **Infrastructure Rehabilitation in the U.S. Virgin Islands**

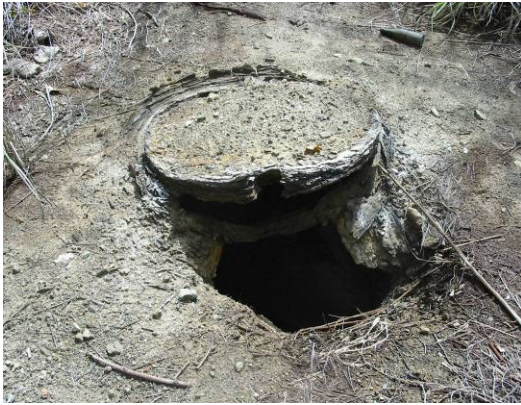
*Sewer Manhole Corroded by Hydrogen Sulfide Gas, St. Croix*

In some cases, due to the extreme levels of the very corrosive hydrogen sulfide, portions of manholes and pipe were nonexistent. Point repairs commenced immediately using both no dig and dig replacement methods. Technologies used included cured-in-place liners, spiral-wounded PVC, slip linings, epoxy coatings, pipe bursting, sealing grouting and others. To fully evaluate these repair options and build local capacity in these new technologies for manhole and pipe repairs, several specialty manufacturers of these repair products and technologies from the mainland were invited to participate in a two-day seminar on St. Croix to explain and demonstrate the benefits and applications of their products and establish licensing agreements with the local contractors who would use these repair products and technologies.

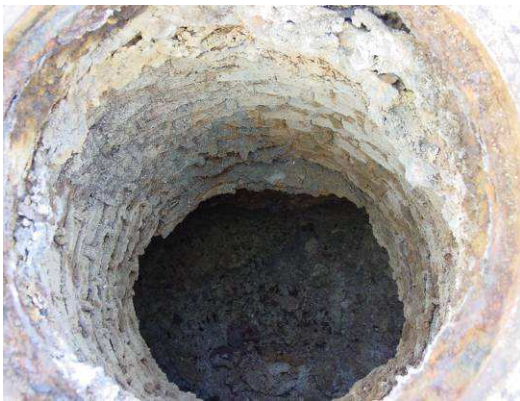
*Manhole Concrete Deteriorated by Hydrogen Sulfide Gas, St. Thomas*

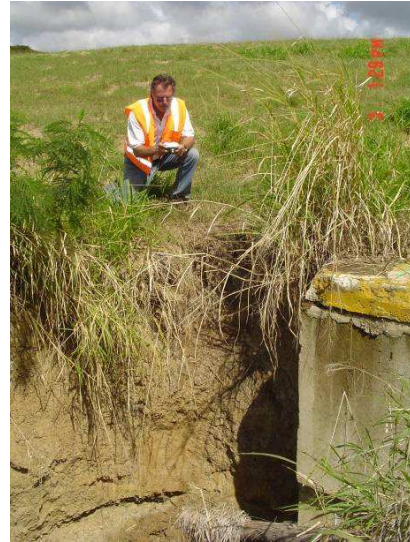
*Hoyle, Tanner's Dick Perez Investigates Sinkhole by Sewer Manhole, St. Croix*

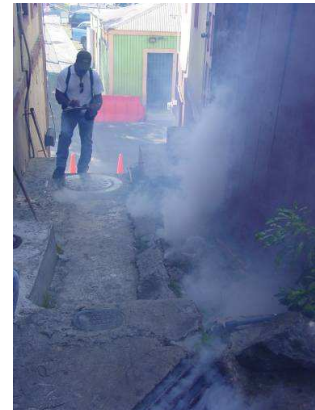
*Smoke Testing to Locate Deteriorating Sewer Line, St. Thomas*

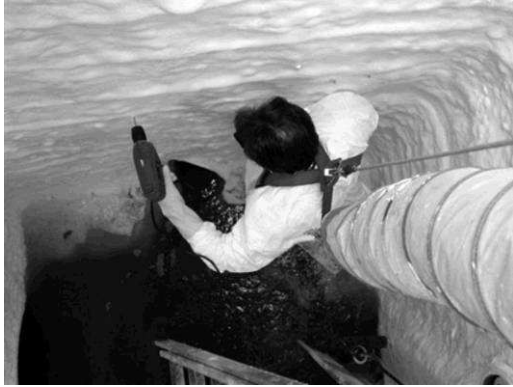
*Epoxy-Lining Manhole Repair,  
St. Thomas*

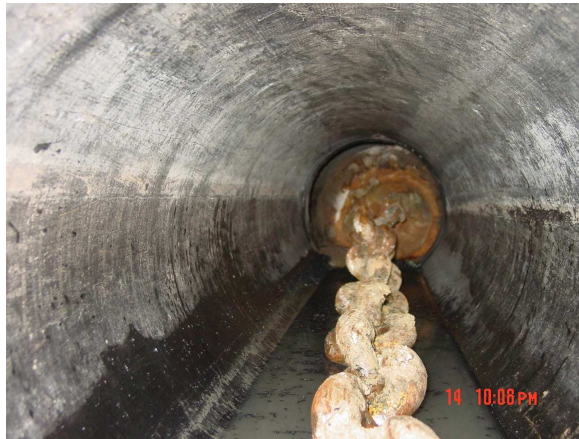
*Pipe Bursting Repair, St. Croix*

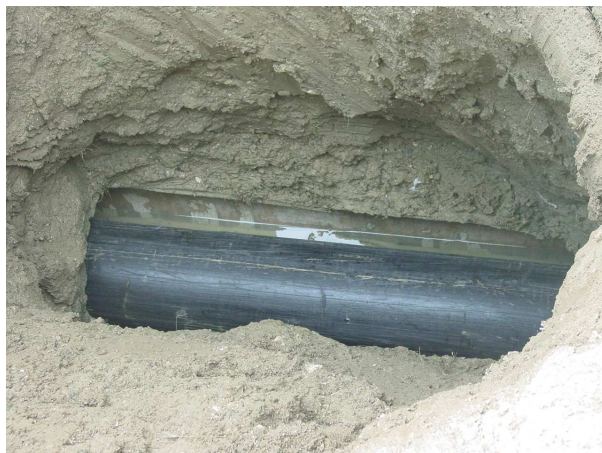
*Slip Lining Repair, St. Croix*
